# Inspection Report

**Property Address:**  
8135 Shady Grove Rd  
Mechanicsville VA 23111

**Burgess Inspections Inc.**

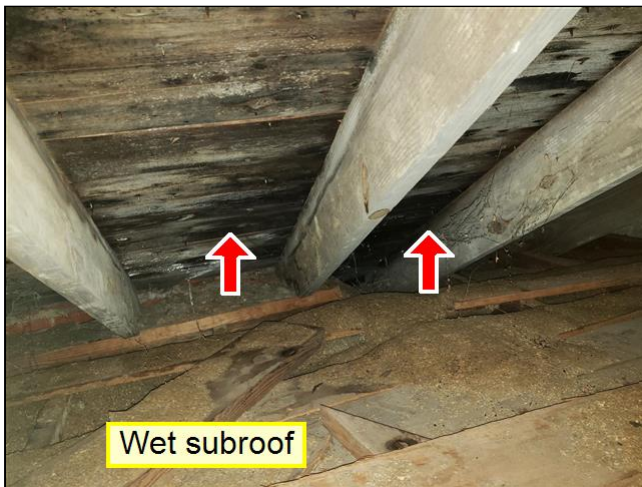
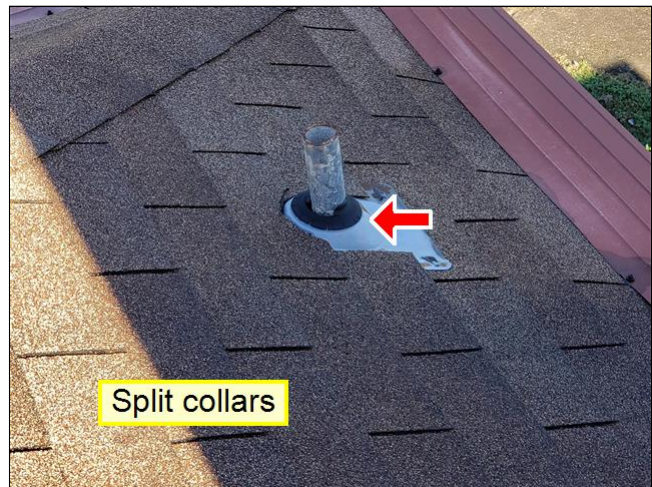
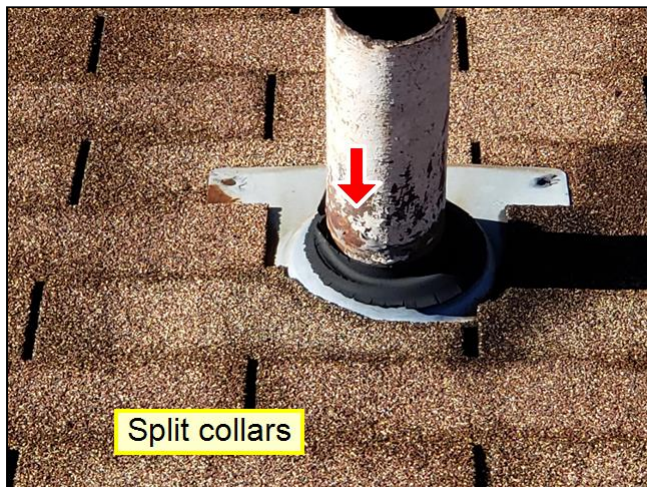
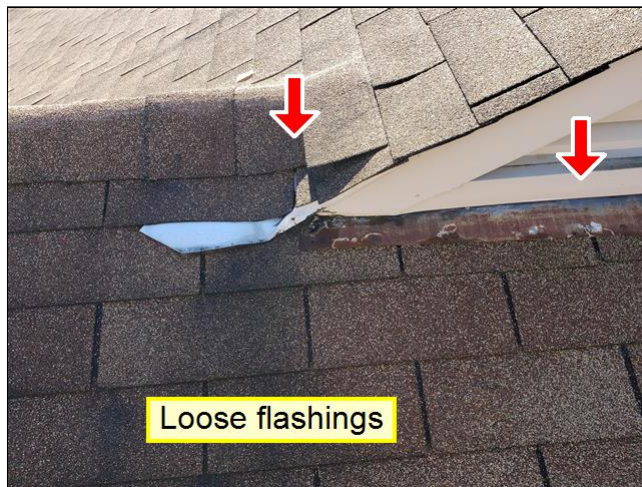
**1 - Wet sub roof noted on the right above the chimney**

**2 - Split pipe collars**

**3 - Loose flashings**

**4 - Shingle wear -**

**Have a Licensed Roofer - repair/replace the roof as needed (EXAMINE ENTIRE ROOF) - the following items were noted -**

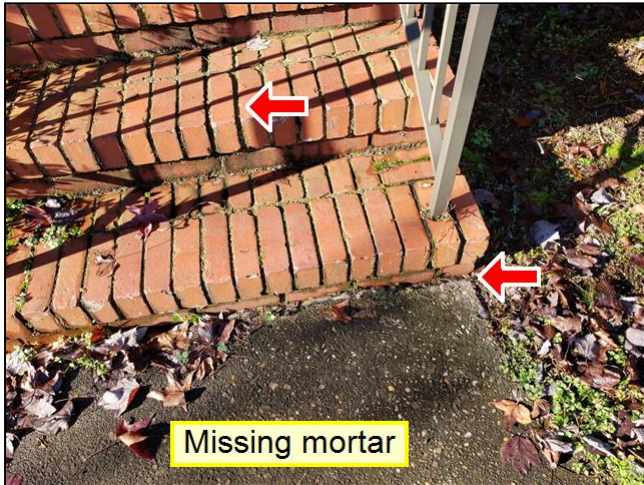
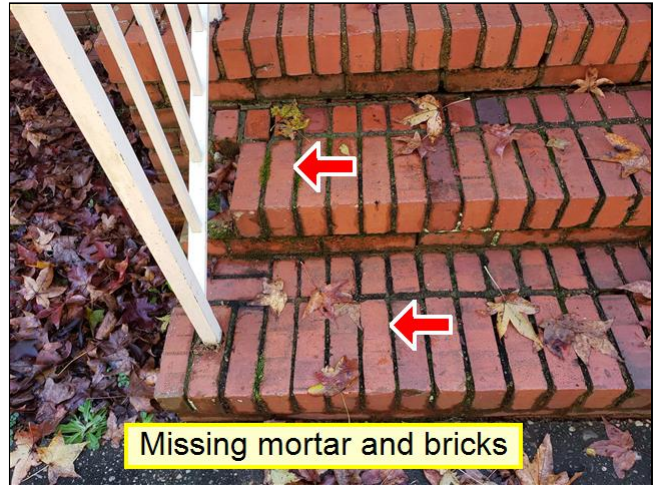
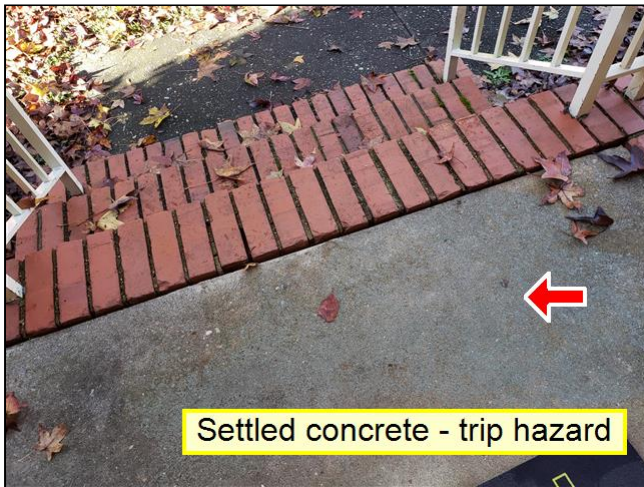
**1 - Missing mortar on the front steps and stoop**

**2 - Loose rails at the front stoop**

**3 - Missing mortar, loose/missing bricks and settled concrete at the kitchen stoop -**

**A - Correct the stoops as needed - the following items were noted -**

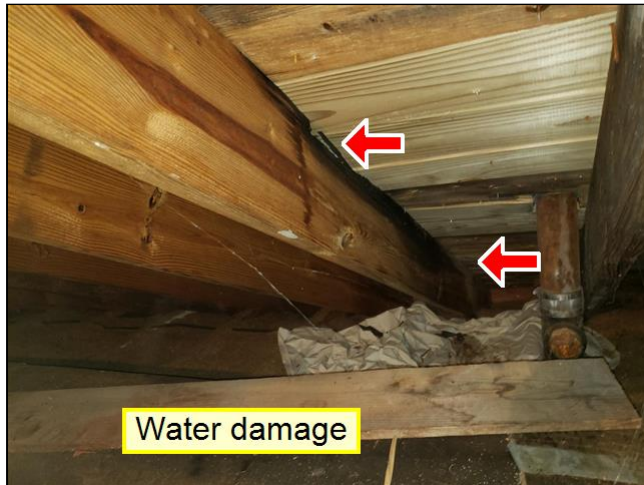
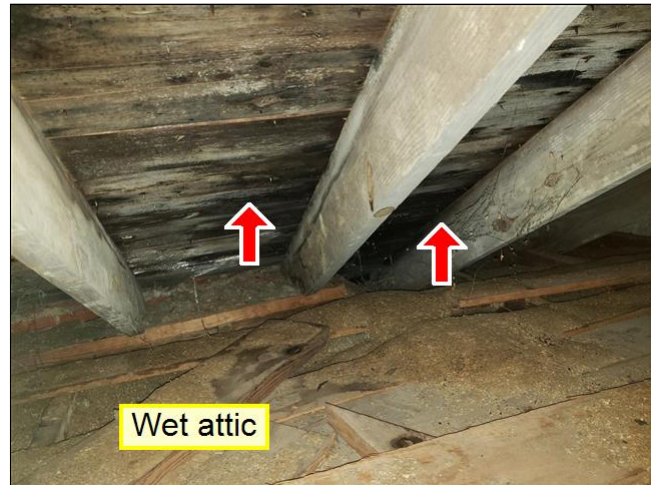
**The roof system has been very wet at some point. Fungus noted throughout. High moisture levels above 40% were noted in various areas. Some evidence of structure damage.**

**A - Repair the rotted floor system noted under the hall bath and any other damage discovered by the moisture company**

**B - Repair any roof structure damage discovered by the moisture company -**

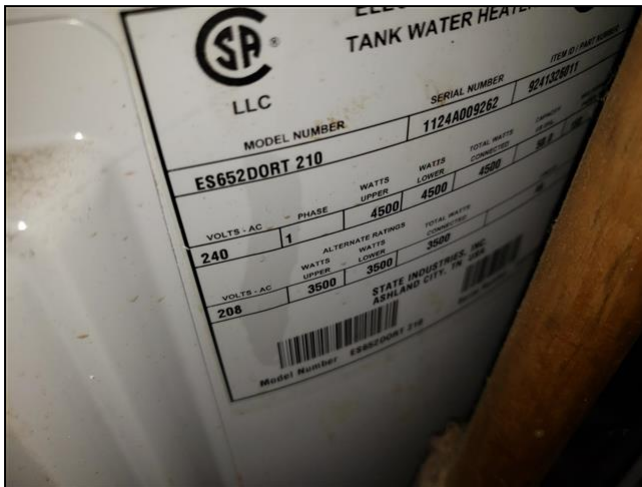
5.2 Item 1(Picture)

Water heater

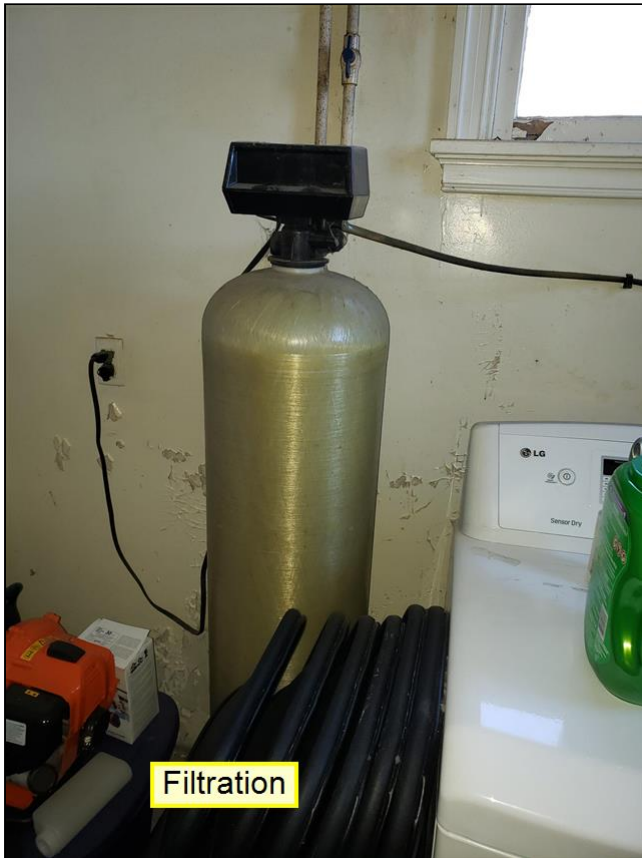
5.7 Item 1(Picture)

Comments: Not Inspected

We do not inspect filtering systems or their operation. If you have any concerns we recommend you have it further evaluated by a qualified person and corrected if needed.

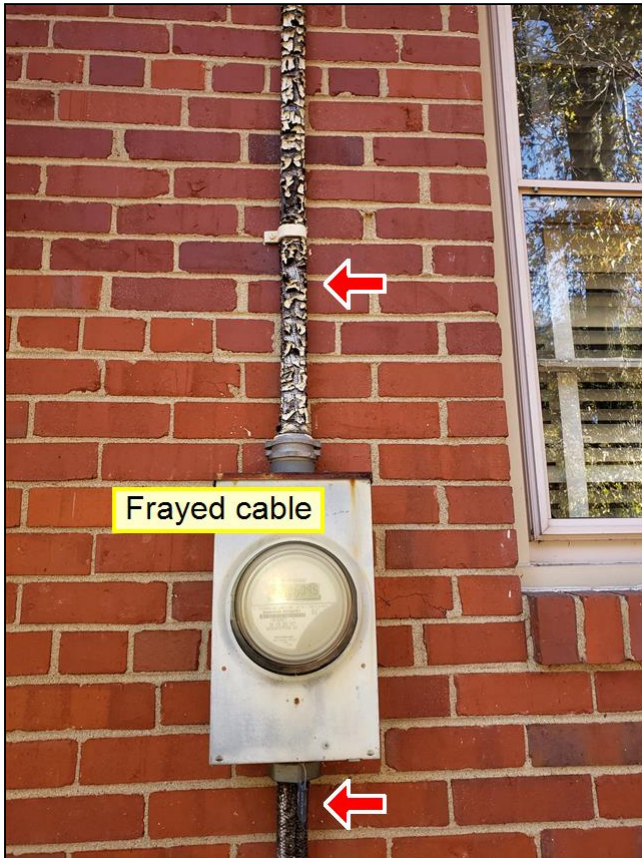
6.0 Item 1(Picture)

The electrical service conductors are frayed at wire sheathing outside and needs repair or replace.

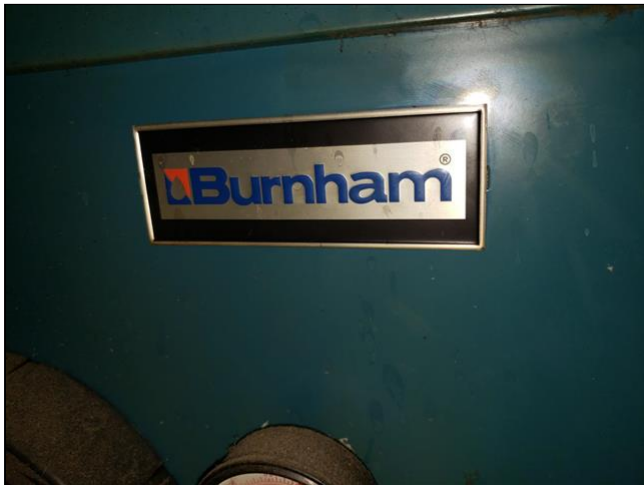
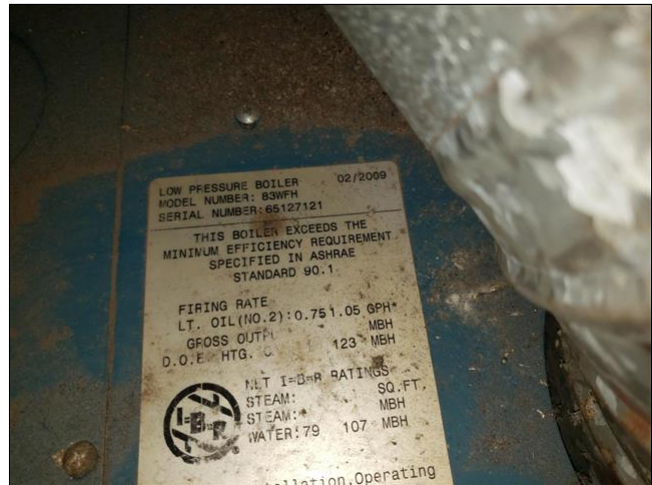
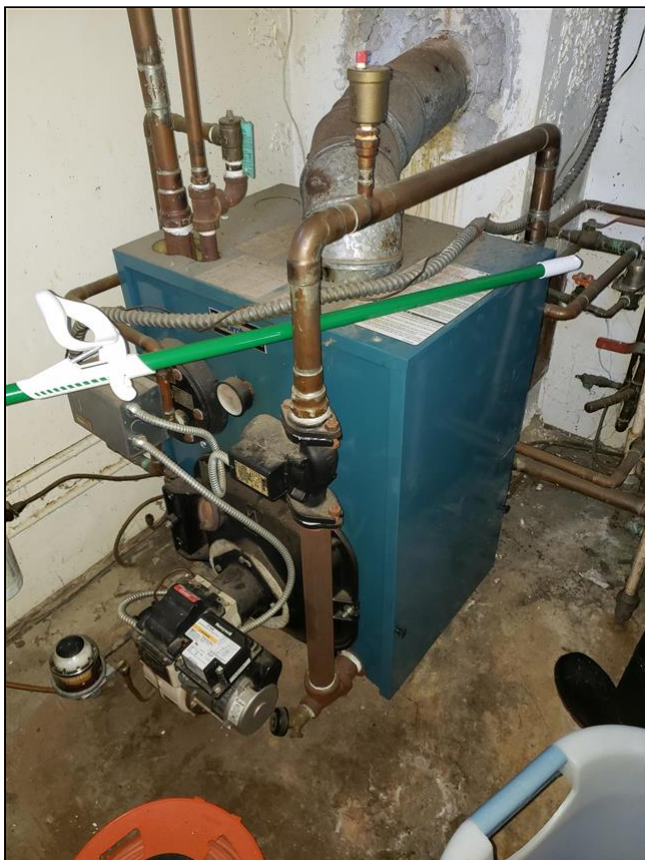
The oil boiler is not running due to the underground tank having water in it.

**A buried oil tank was noted. I recommend having it tested and corrected by a licensed company in this field.**

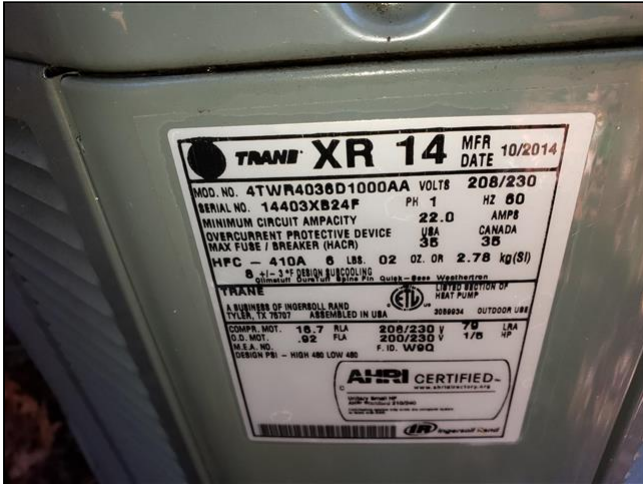
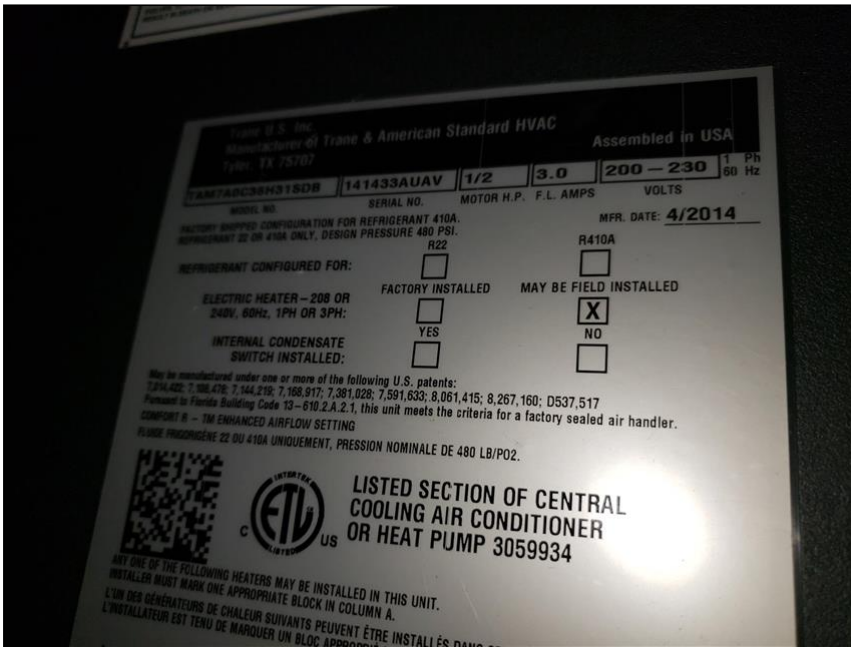
The temperature was too cool to test the AC. There is a chance that the compressor could be damaged operating the AC unit. If you have any concerns, recommend having the AC further evaluated by a qualified person in this field.

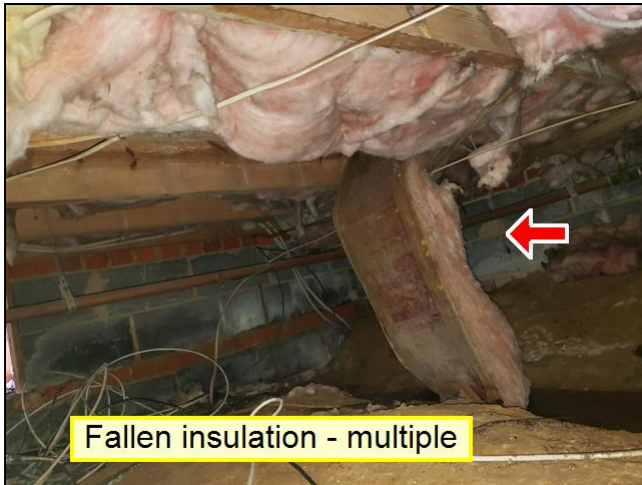
8.1 Item 1(Picture)

**Fallen insulation - multiple**

**Have a Handyman install insulation where missing/fallen in the crawl -**
